Do You Know Where Your Fault Currents are Flowing?

Robert Fuhr, P.E., Senior Member IEEE & Jessica McCue

PowerStudies, Inc. was hired to investigate a very strange power outage problem that was happening to a group of three buildings in Issaquah, WA. The campus was fed by the local utility company, Puget Sound Energy (PSE), out of their Pickering Substation. This substation has several feeder circuits that feed not only the campus, but other parts of Issaquah as well.

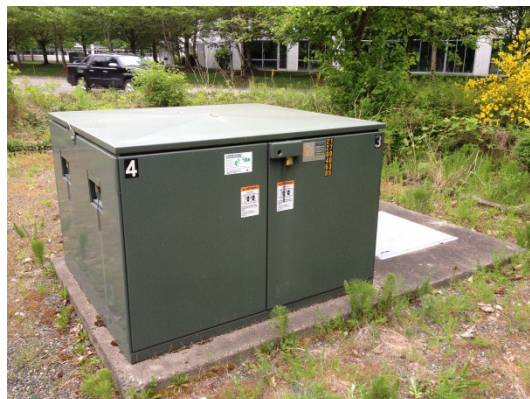
Two of the buildings contain two 1,500 kVA transformers that step down the voltage from 12,470 to 480 Volts. The third building has only one transformer. The campus is fed by a main S&C Vista Switch. The Vista Switch has a solid state electronic trip unit set to trip on phase and ground faults.

The problem first arose approximately nine years ago. A line-to-ground fault occurred on an adjacent PSE Pickering Substation feeder, not on the circuit feeding the campus. This fault tripped the PSE adjacent feeder breaker (which is correct) but also caused the campus Vista Switch to trip, blacking out the buildings. Obviously, this should not have happened.

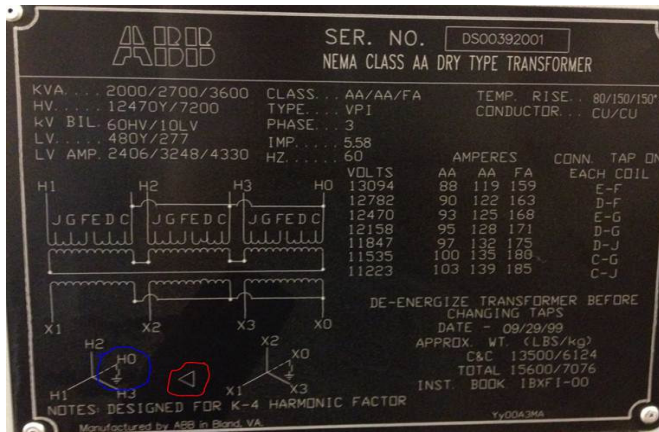
One type that caught my eye was the Wye-grounded/Delta/Wye-grounded transformer. This winding configuration can act as a low impedance path for line-to-ground currents on a system creating a path for the zero sequence currents to flow. This allows the line-to-ground fault current to split and take an alternate path back to the Pickering Substation. The line-to-ground fault currents will flow to ground at the fault location and then flow up the ground connection of the primary side of the three winding transformer. The currents are redistributed (almost evenly) on to the phases.

Could this be the problem? The use of three winding transformers in commercial buildings is extremely rare. In fact, I have never seen this in my 33 years of experience in the industry. They are usually used at utility power plants to save money and space. To test the theory, I modeled the system in SKM and proved that this type of three winding transformer can indeed re-distribute line to ground fault currents back onto the phases.

A field visit to the site and buildings confirmed my suspicion that the transformer was a Wye-grounded/Delta/Wye-grounded unit. Again, the article helped me to determine the solution to the problem by removing the primary to ground neutral link. This changed the transformer winding configuration to a Wye-Ungrounded/Delta/Wye-grounded unit. With the link removed, the ground fault current can no longer flow up through the neutral link back to the phases.

In the fall of 2013, the Vista Switch was opened and the three buildings were de-energized. The Valley Electric electricians grounded each transformer primary, tested for the absence of voltage, and removed the primary to neutral link. Now that the cause has been determined and solution implemented, the mystery trips afflicting the campus buildings will not occur.
